Submarine Groundwater Discharge as a Potential Hidden Pathway for Eelgrass Decline
in San Juan County

Blinks – NSF REU – BEACON Program 2014

Summer 2014

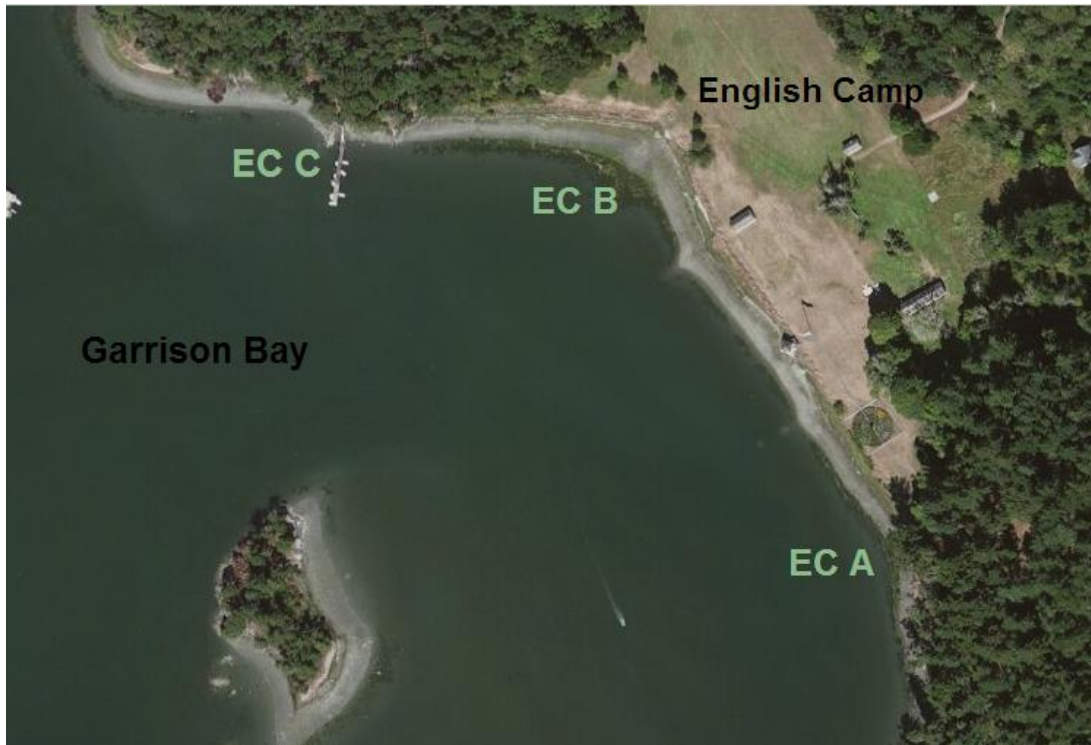
Figure 2: Sampling sites at English Camp/Garrison Bay.

Three sample locations and a control location were selected at English Camp, and two were chosen at American Camp. English Camp (EC) sampling locations are denoted by letters A, B and C, while the control location is site D. EC A was chosen due to the presence of green algae, which could indicate eutrophication due to nutrient loading. EC B and C also appeared somewhat eutrophic, while D lacked signs of eutrophication. American Camp (AC) sampling locations are A and B. AC B was chosen at a location with visible discharge and algal blooming, while AC A was chosen for its clean appearance.

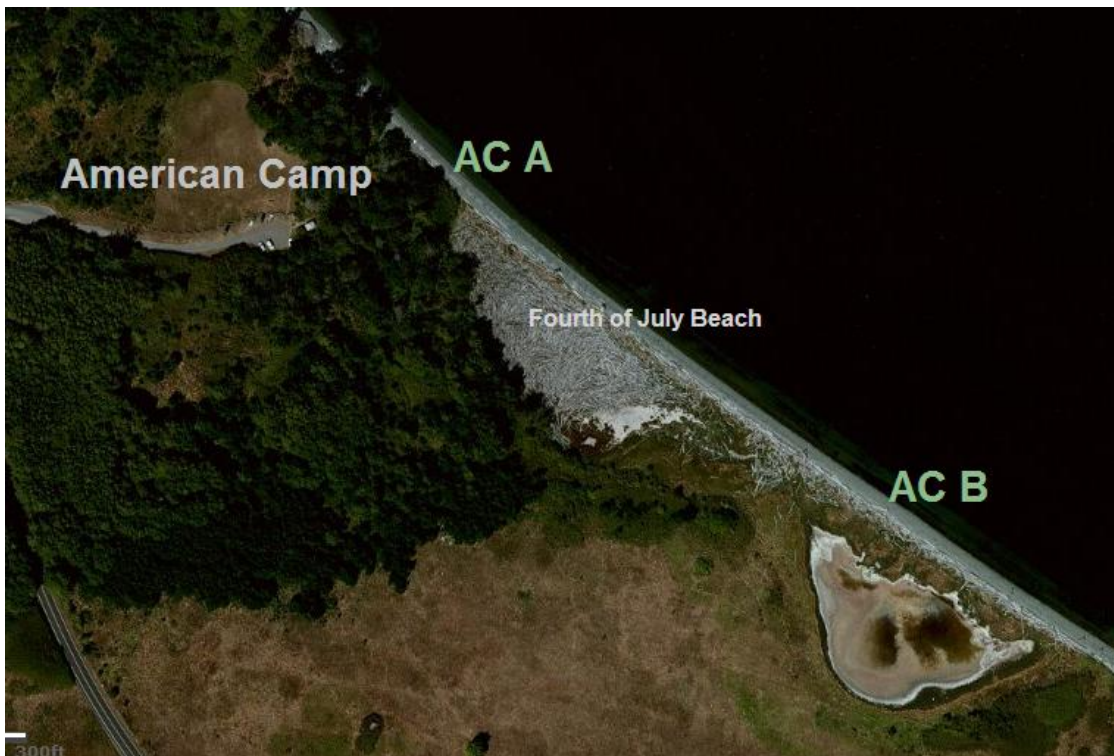
Figure 3: Sampling locations at Fourth of July Beach at American Camp.

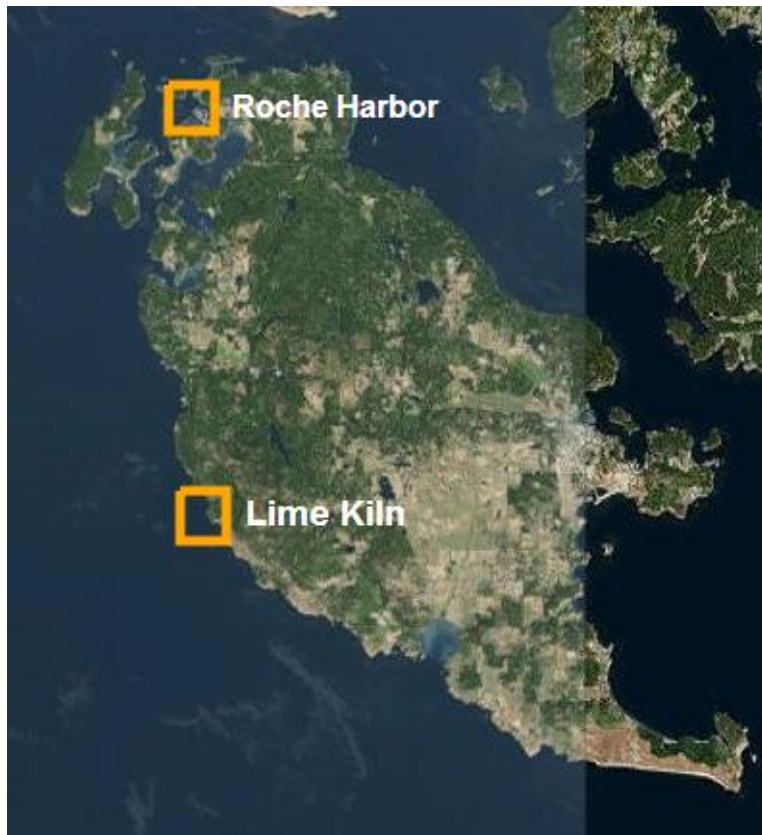
Figure 4: Lime Kiln and Roche Harbor sample sites on San Juan Island.

Samples of submarine groundwater discharge were collected on the west side of the island near Lime Kiln and at Roche Harbor on the north side of the island. No duplicates were taken for these samples.

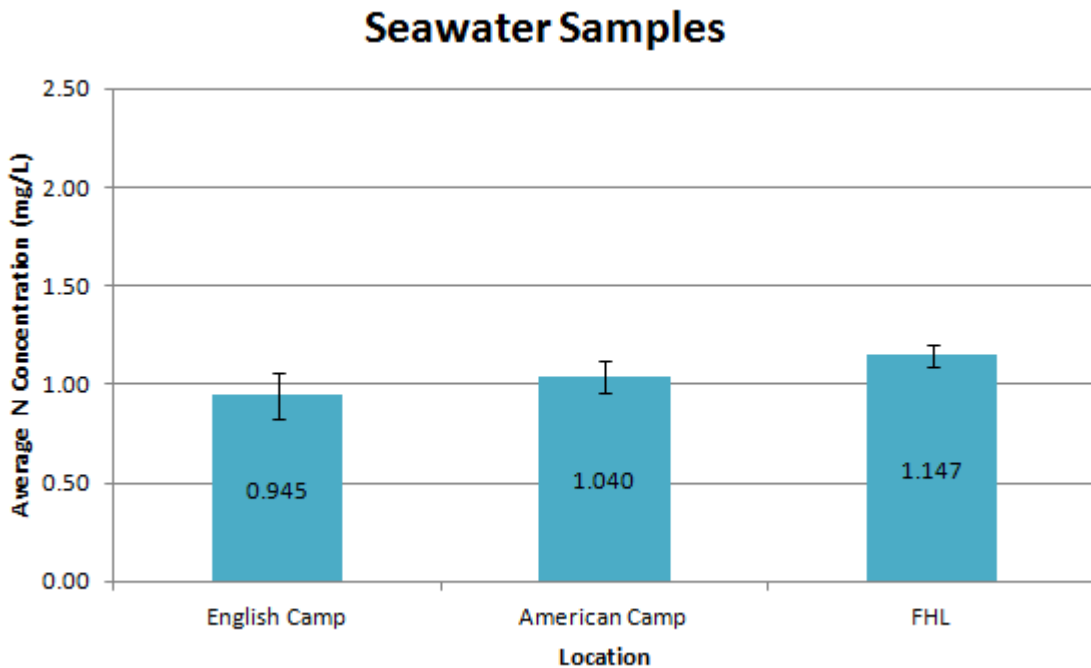
Chart 1: Total N in seawater samples.

Samples at English Camp and American Camp were taken in duplicate over three sampling dates as described above. Friday Harbor Lab seawater results represent a single sample taken in duplicate on June 30. Submarine groundwater discharge samples represent single samples without duplicates taken on July 25 and thus have no error associated with results. Nitrogen concentrations for both sample groups are as follow

Submarine groundwater discharge represents a potential vehicle for nutrient pollution. In this study, we found that nitrogen concentrations in seawater samples at English Camp, American Camp, and Friday Harbor Laboratories were approximately 1 ppm. Total nitrogen concentrations in seawater are typically less than 1 ppm (Sverdrup et al.), so these concentrations are elevated and indicate some degree of nitrogen loading. In contrast, SGD samples range from approximately 1 ppm to over 2 ppm. This result of 2.096 ppm for Roche Harbor is double the ambient concentration of the seawater samples and conclusively points to nitrogen loading in this area. There are several factors that may be contributing to nitrogen loading near Roche Harbor, which are a resort community and the most commercially developed area on the island. Perhaps most enlightening is the reliance on septic tanks by the Roche Harbor community (Simonson, 2014), as well as elaborate gardens in the area (Roche Harbor). Thus, nitrogen from these sources may be seeping into coastal groundwater aquifers and entering subtidal waters via submarine groundwater discharge.

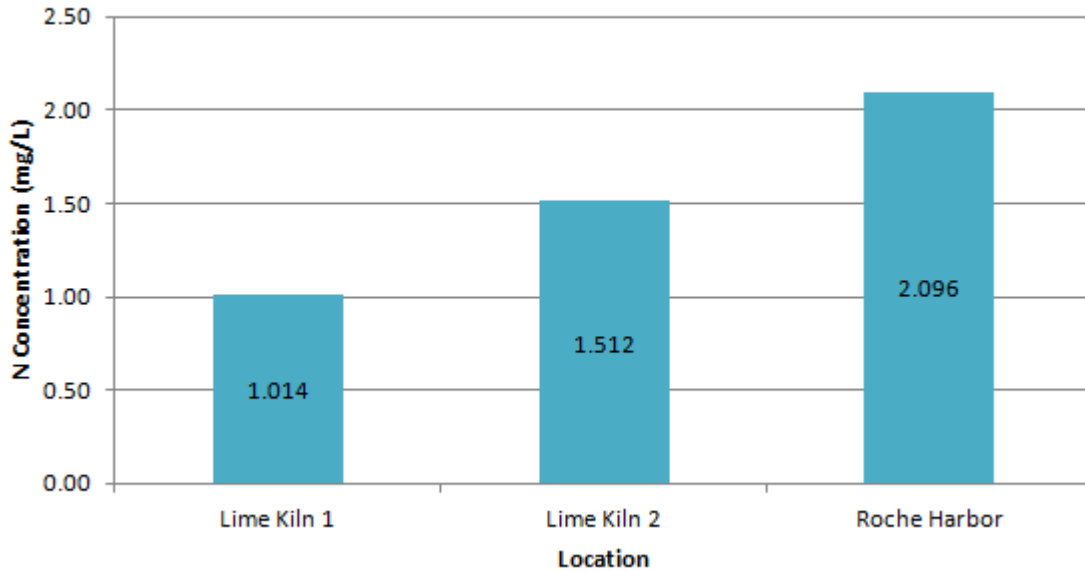
Chart 2: Total N in SGD samples.
